Manhole Inspection Summary

Manhole # S13AA1026MH

Location Address: **3704 TOWANDA AVE**

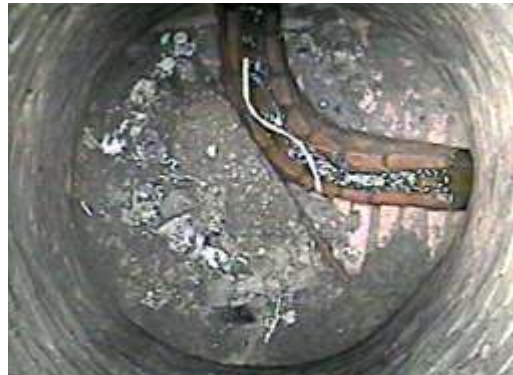
Top View

DEBRIS ON BENCH

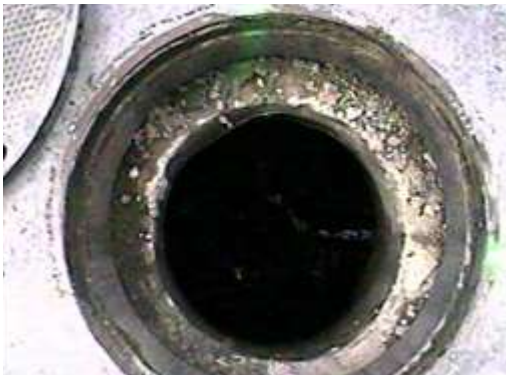
Top View

Frame Offset: **3** (in.) Condition: ☒ Sound ☐ Cracked ☐ Leaks

FRAME OFFSET

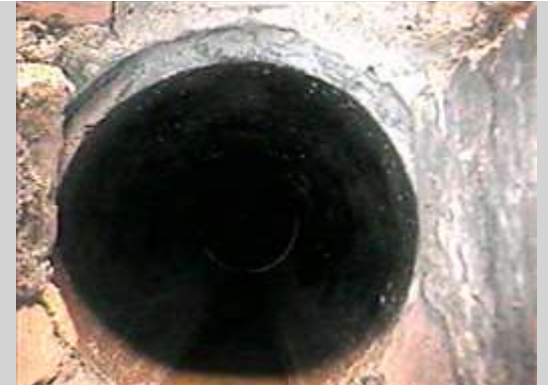
12 O'Clock Outflow

8 in. Circular Gravity Sewer
Pipe Out @ 12 O'Clock

FRAME OFFSET

Pipe Height: (in.) Direct
Pipe Material: **Clay** ☐ Pipe Lined
Invert Depth: **7.20** (ft.) Flow Characteristics: **Slow**
Deposits: ☒ None ☐ Mud ☐ Sludge ☐ Debris ☐ Grease
Silt Depth: (in.) Deposits Extent:
Infiltration: **None** Pipe Seal Cond: **Sound**

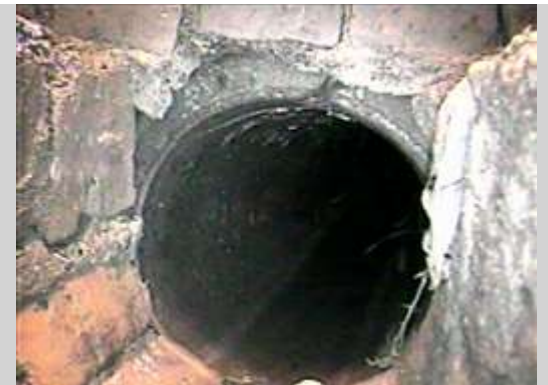
3 O'Clock Inflow

8 in. Circular Gravity Sewer
Pipe In @ 3 O'Clock

Pipe Height: (in.) Direct
Pipe Material: **Clay** ☐ Pipe Lined
Invert Depth: **6.98** (ft.) Flow Characteristics: **Slow**
Deposits: ☒ None ☐ Mud ☐ Sludge ☐ Debris ☐ Grease
Silt Depth: (in.) Deposits Extent:
Infiltration: **None** Pipe Seal Cond: **Sound**
